Re: HOA Road Assessment

Lazy TH Estates Road Assessment

Pavement Assessment and Rehabilitation Options

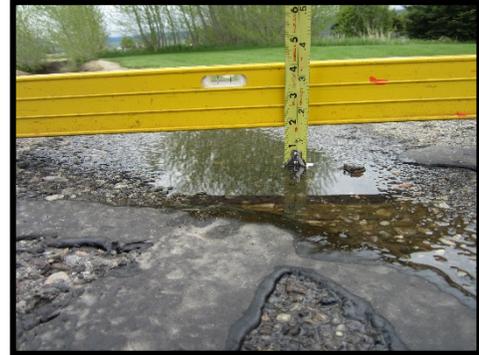
Photo III.1: *Terrance Loop Rd Settlement Station 6+00 – “Bird Bath”*

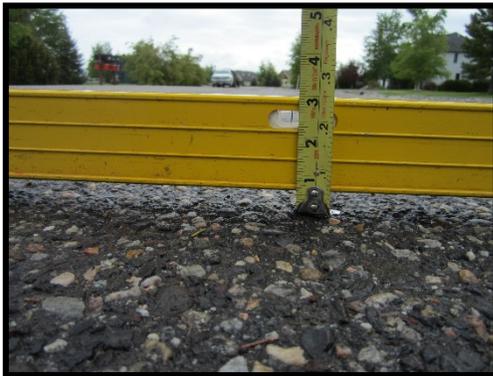
Photo IVII.2: *Rutting on Sir Arthur Dr. Station 10+00*

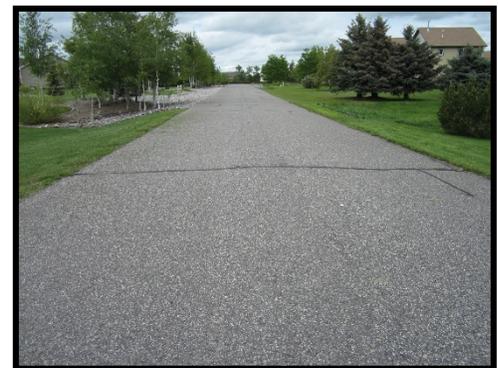
Photo III.3 *Transverse cracking Lucille Ln Station 6+00*

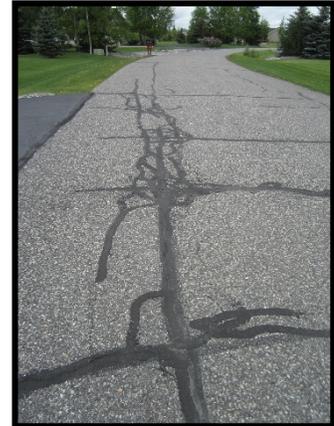
Photo III.4: *Lucille Ln
Longitudinal Cracking
Station 10+00*

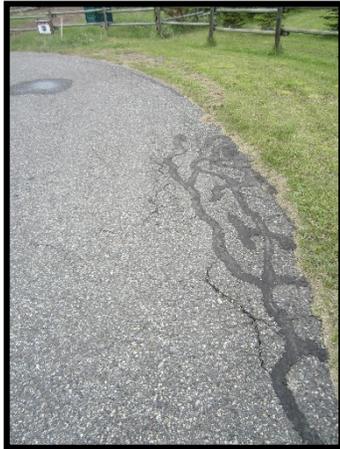
Photo III.5: *Rodeo Ct. Edge
Cracking Station 4+00*

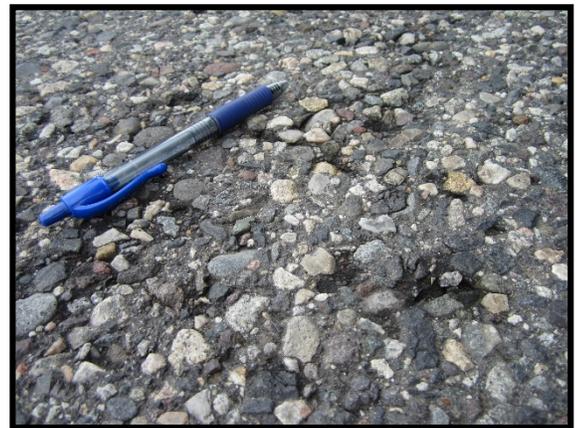
Photo III.6: *Hydro scouring Terrance Loop Rd at
Station 12+00*

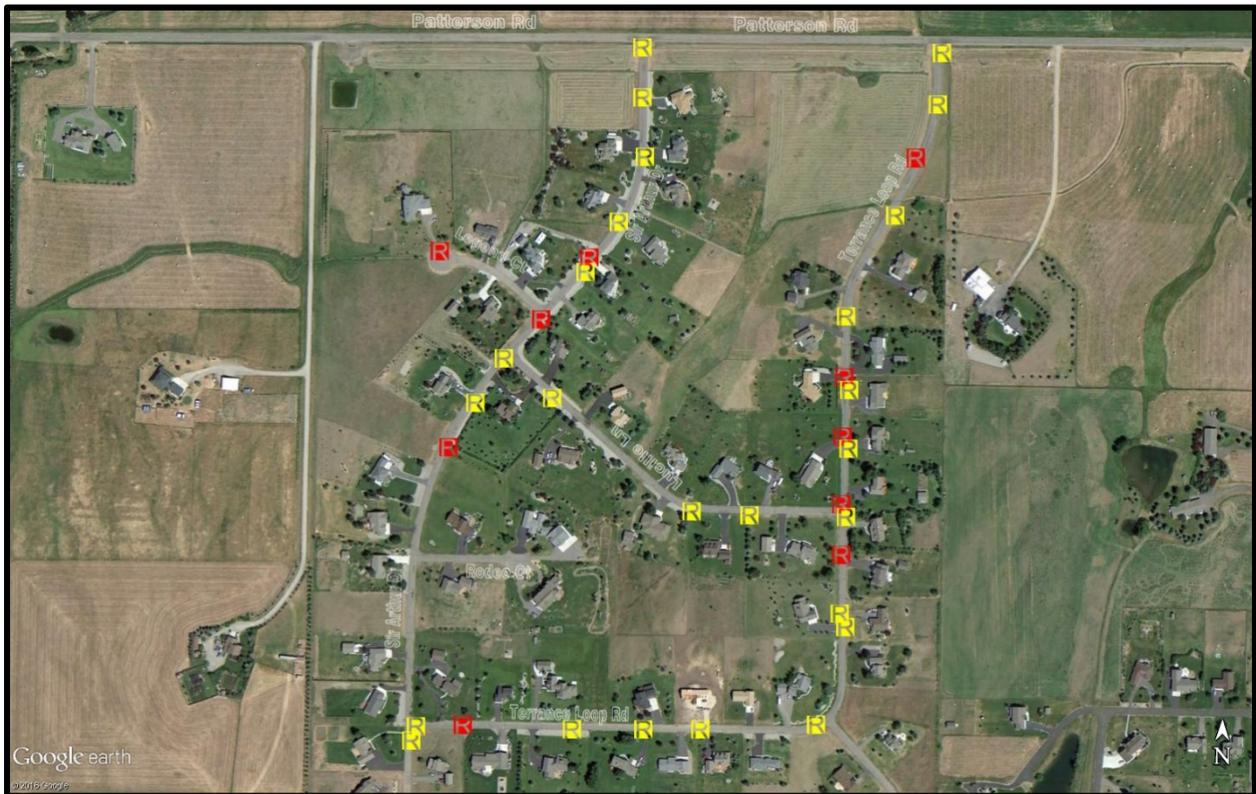
Although rutting was not a major issue, it was observed that many locations exhibited at least some minor rutting of 0.125" or less. Of the 52 stations observed, 24 locations, shown in yellow, exhibited rutting from 0.25" to 0.5" and another 10 locations, shown in red, had rutting greater than 0.5".

Photo V.3: Lazy TH Rutting Map. Yellow indicates 0.25" – 0.5" of rutting. Red shows areas greater than 0.5" of rutting.

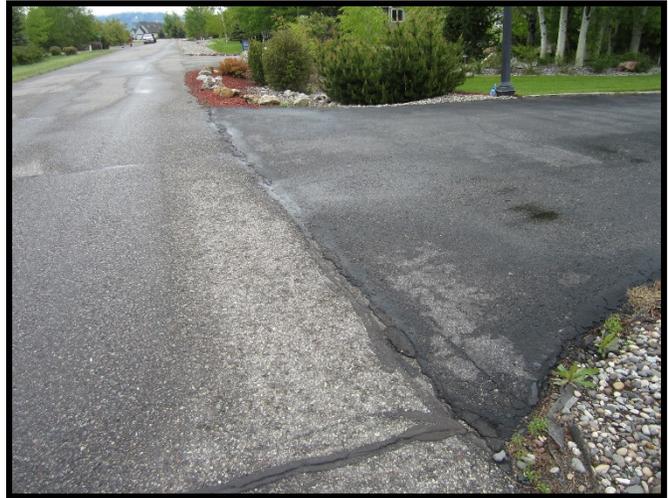
Photo V.4: Crack sealant appears to be failing in tension on driveway interface and traverse crack across Sir Arthur Dr. at Station 13+00.

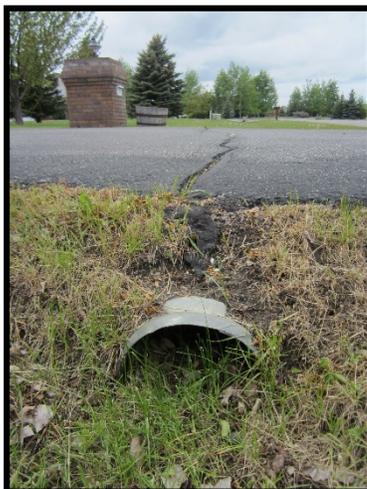
Photo V.5: Driveway culvert full of sediment Lucille Ln. at Station 11+00.

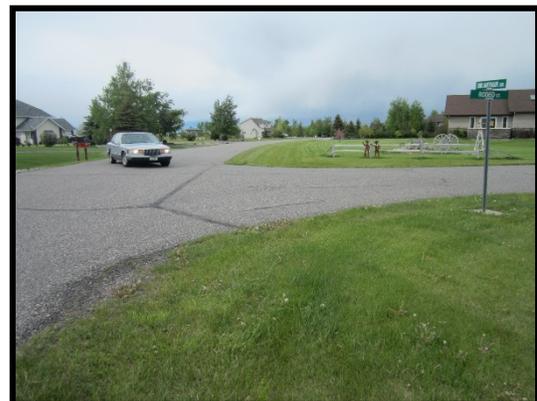
Photo V.6: No culvert at the intersection of Rodeo Ct. and Sir Arthur Dr. at Station 20+00.

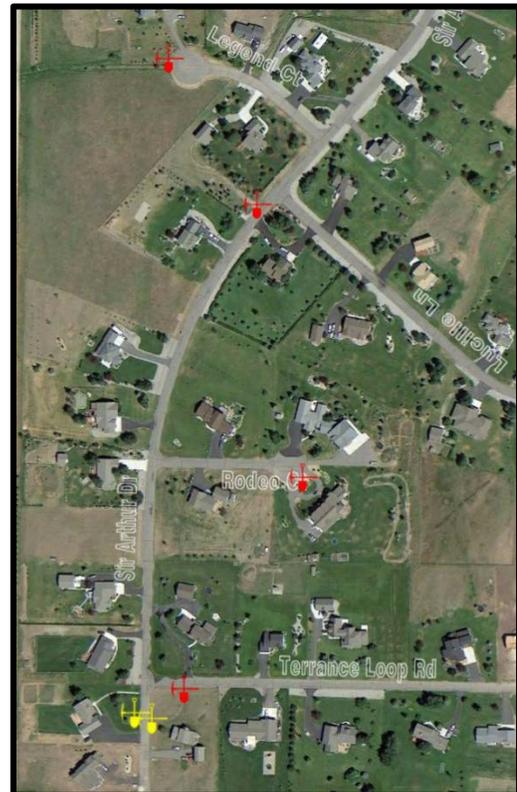
Photo V.8: Map showing ditch maintenance spots.

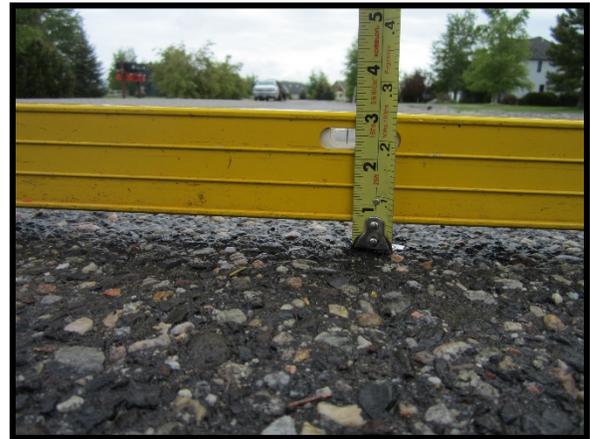
Photo V.9: Significant rutting on Sir Arthur Dr. at Station 10+00.

This road is one of the best roads among the six in Lazy TH Estates with its condition falling into the fair to good category. However, some rutting without alligator cracking was observed. The entire length of road averages approximately 0.25 inches of rutting depth in both lanes. Most of the visible cracks recorded on Sir Arthur have been previously treated with crack sealant and have started to crack again. Roughly 2,300 linear feet of sealed and unsealed cracks were recorded. Also the wearing surface has become highly oxidized from 20 years of use will likely lead to more cracking in the near future. The asphalt is also experiencing scouring or raveling in many places which increases surface area as well as the rate of oxidation. From our observations we would suggest removing and replacing any base failure areas (rutting teamed with alligator cracking) followed with a chip seal treatment in the near future. Depending on how the chip seal performs, we would then anticipate 5 to 7 years later a 1-inch mill of the existing surface pavement followed with a 2-inch overlay with new hotmix asphalt. Due to plow and studded snow tire abrasion we have observed, we would also propose a chip seal treatment 7-10 years after the overlay to seal and protect the surface.

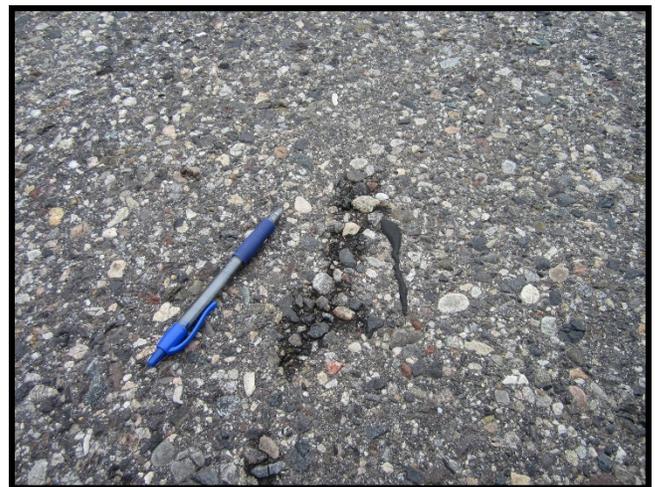
Photo V.10: Typical hydro-scouring on Sir Arthur Dr. Station 18+00.

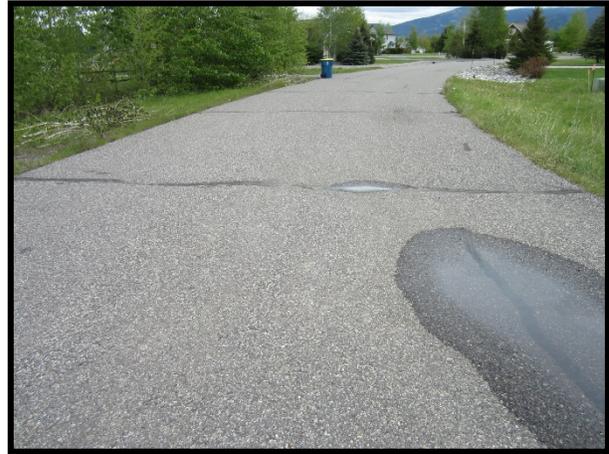
Photo V.11: Settlement at Station 4+00 forming a "Bird Bath."

Legend Ct. is a 400-foot cul-de-sac street off of Sir Arthur Dr. providing access to five lots. The end of the cul-de-sac shows some settlement and cracking. The only concern with this section of road is the settlement areas at the end of the cul-de-sac as well as the absence of ditches around the cul-de-sac. Based on our observations, we propose the same approach to a long term solution as previously mentioned above.

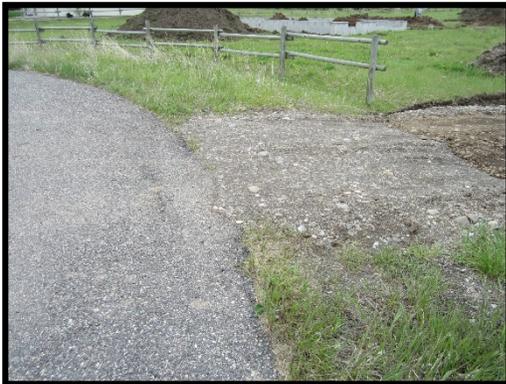
Photo V.12: No drainage at the cul-de-sac of Legend Ct. at Station 4+00.

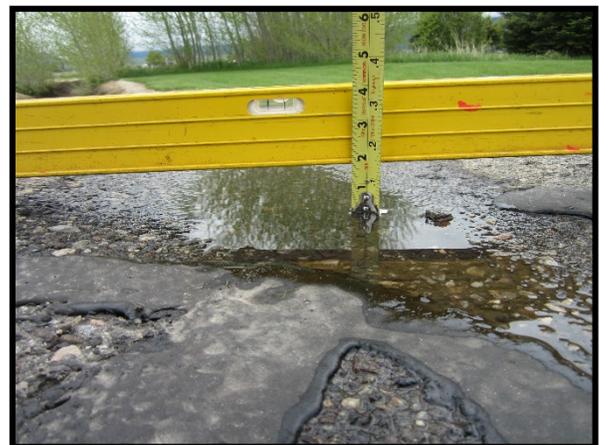
Terrance Loop (3,575 feet) is in the worst condition among the six roads in Lazy TH Estates with the condition falling into the poor to fair category. Rutting appears to be one of the leading problems on this section of the sub-division, with 70% of the observation stations having noticeable rutting depth of at least 0.25", the stations without an observation had 0.125" of rutting. Most of the cracks recorded on Terrance Loop have been previously treated with crack sealant and have cracked again. Roughly 1,700 linear feet of sealed and more recent unsealed cracks were recorded. The wearing surface has become highly oxidized from age and will likely cause more cracking in the future which may lead to additional problems. The surface is also experiencing scouring or raveling in some places which increases the rate of oxidation. From our observations we would suggest removing and replacing any base failure areas (rutting teamed with

Photo V.13: Terrance Loop rutting/settlement at Station 6+00.

alligator cracking) followed with a chip seal treatment in the near future. Depending on how the chip seal performs, we would then anticipate 5 to 7 years later a 1-inch mill of the existing surface pavement followed with a 2-inch overlay with new hotmix asphalt. Due to plow and studded snow tire abrasion we have observed, we would also propose a chip seal treatment 7-10 years after the overlay to seal and protect the surface.

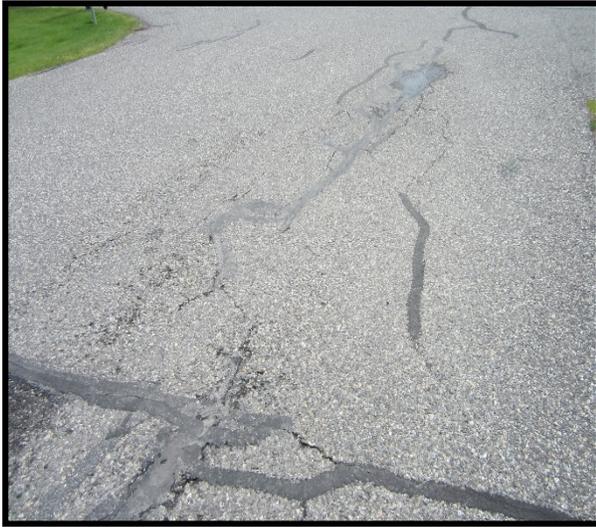
Photo V.14: Terrance Loop cracking and hydro-scour at Station 16+00.

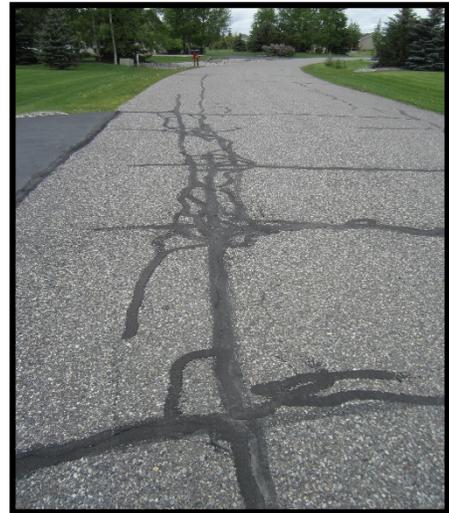
Photo V.15: Lucille Ln. sealed cracks that are starting to crack again at Station 12+00.

Lucille Ln. (1,300 feet) condition falls into the fair to good category and is ranked the second road in the need of maintenance in the sub-division, taking PCI and ADT into account. Again we observed rutting as a concern, more particularly, with the right lane, traveling East bound, having twice as much rutting as the left lane. A majority of the observation points (63%) displayed rutting depths of 0.25 inches or greater. Most of the cracks recorded on Lucille that have been previously treated with crack sealant are beginning to re-crack. Roughly 1,300 linear feet of sealed and recent or unsealed cracks were recorded. Lucille Lane displays many of the common pavement issues that have been observed throughout the Lazy TH development. Based on our observations, we propose the same approach to a long term solution as previously mentioned above.

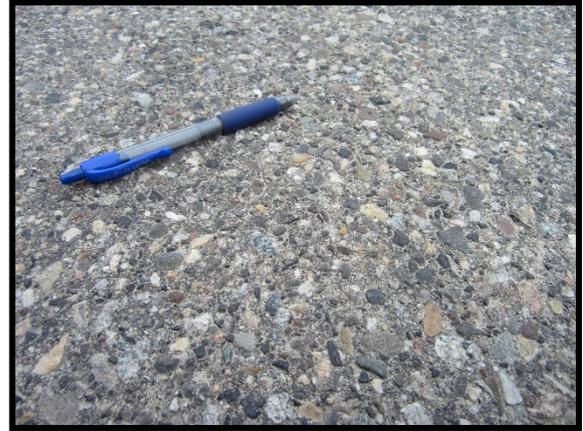
Photo V.16: *Typical Oxidation of Hofer Ln. at Station 2+00.*

Hofer Ln. is a 400-foot street off of Terrance Loop Ln. providing access to only two lots within the subdivision. It also provides connection to existing tracts to the south of Lazy TH. This road appears to be in the best condition of any within the sub-division likely due to minimal traffic. However, oxidation and hydro-scouring along the entire section are the prevailing issues with this road. From our observations we would suggest the same long term solution as the rest of the roads.

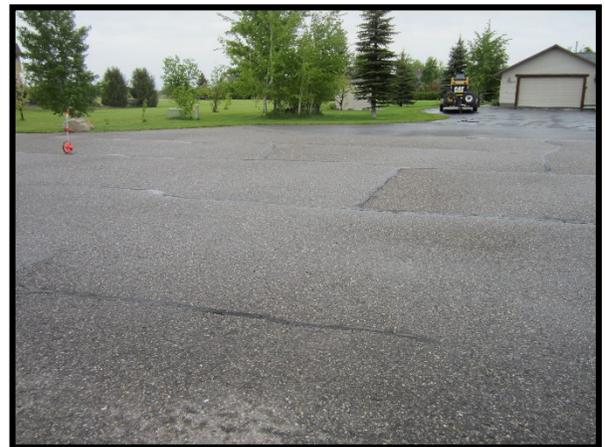
Photo V.17: *Settlement and cracking in the cul-de-sac on Rodeo Ct. at Station 4+00.*

Rodeo Ct. is a 400-foot cul-de-sac street off of Sir Arthur Dr. providing access to four lots. The end of the cul-de-sac shows some edge settlement and cracking due to improper drainage. The main concern with this section is the settlement in the bulb as well as the lack of ditches around the cul-de-sac draining water away from the edge of the road. From our observations we would suggest completing some ditch forming and the same long term solution as the rest of the roads.

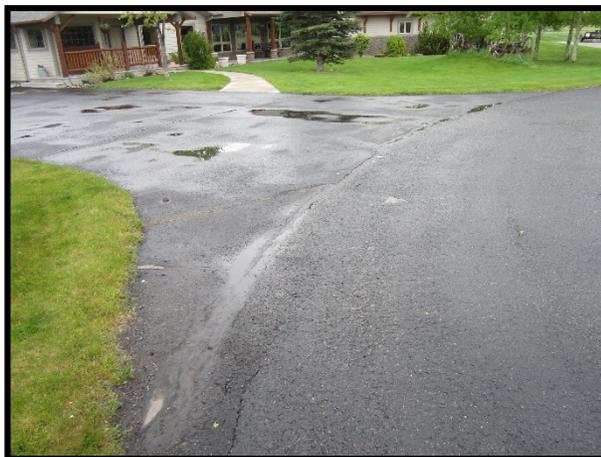
Photo V.18: *Lack of drainage ditches at the cul-de-sac on Rodeo Ct. Station 4+00.*

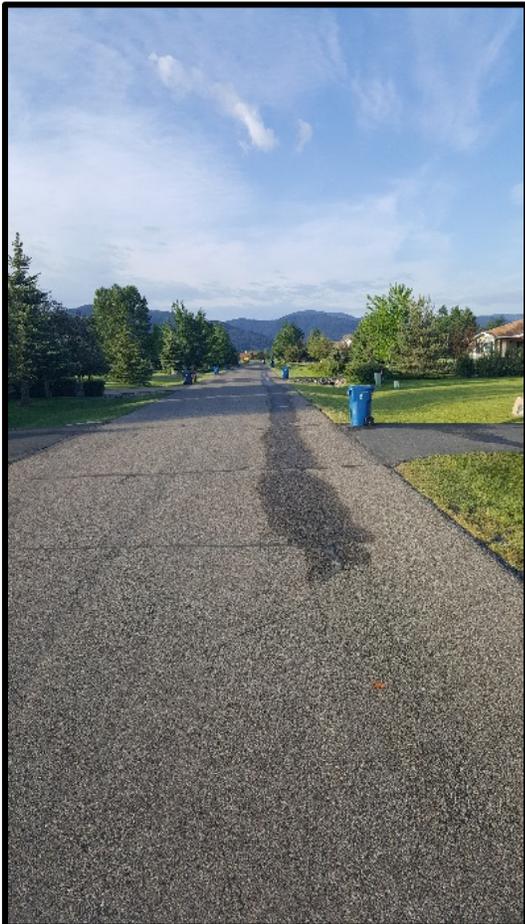
Photo V.19: *Water from sprinklers ponding in rut along Terrance Loop.*
