Engineering and Surveying Inc.

June 6, 2014

RE: Pavement Inspection & Report- Lazy TH Estates Subdivision Roadways, Bozeman, MT (14313)

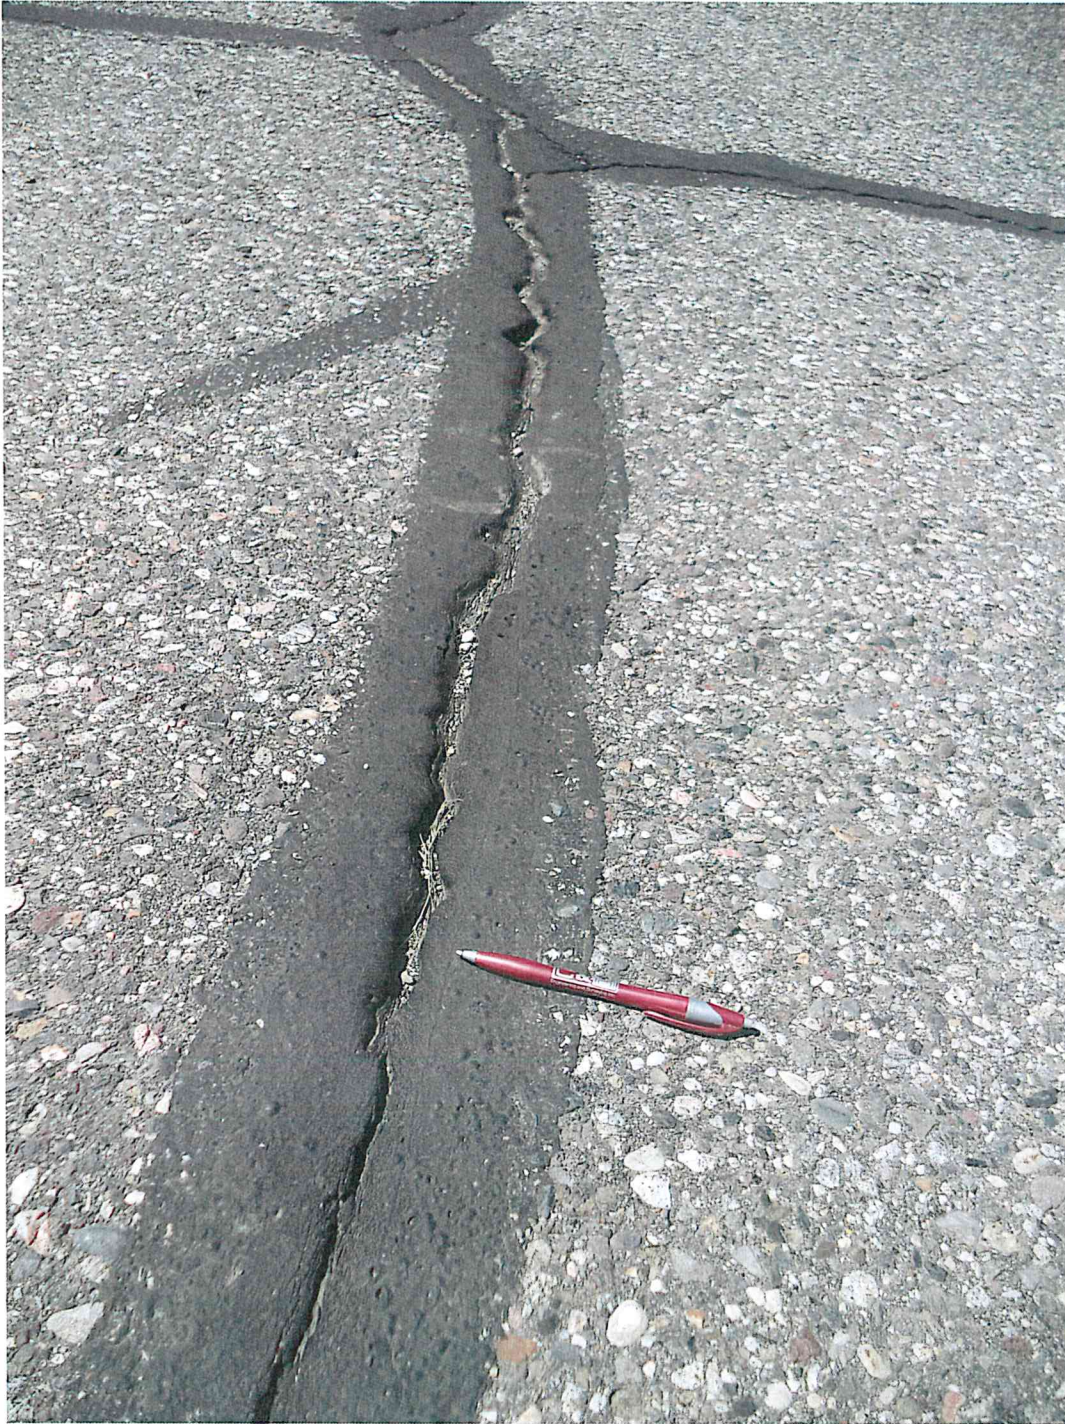
The existing pavement on this roadway appears to be in relatively good condition with some roadway fissures and cracking both perpendicular and parallel with the road. These cracks range in size from 1/16th to 1 inch in width. Many of these cracks have been filled within the past 1 to 2 years (Photo 1). The roadway also has isolated small patches of asphalt that have been replaced ranging in size from a few square feet to approximately 50 square feet (Photos 2 and 3). Generally, the pavement surface is smooth with minor exceptions along the southerly 'east-west' section of the road, where weathering, possibly due to melting and freezing, has occurred.

Picture 1 - typical patched crack
